Cascade Engineering Services, Inc.

Dye and Pry of BGA Solder Joints

CPU Failure Investigation

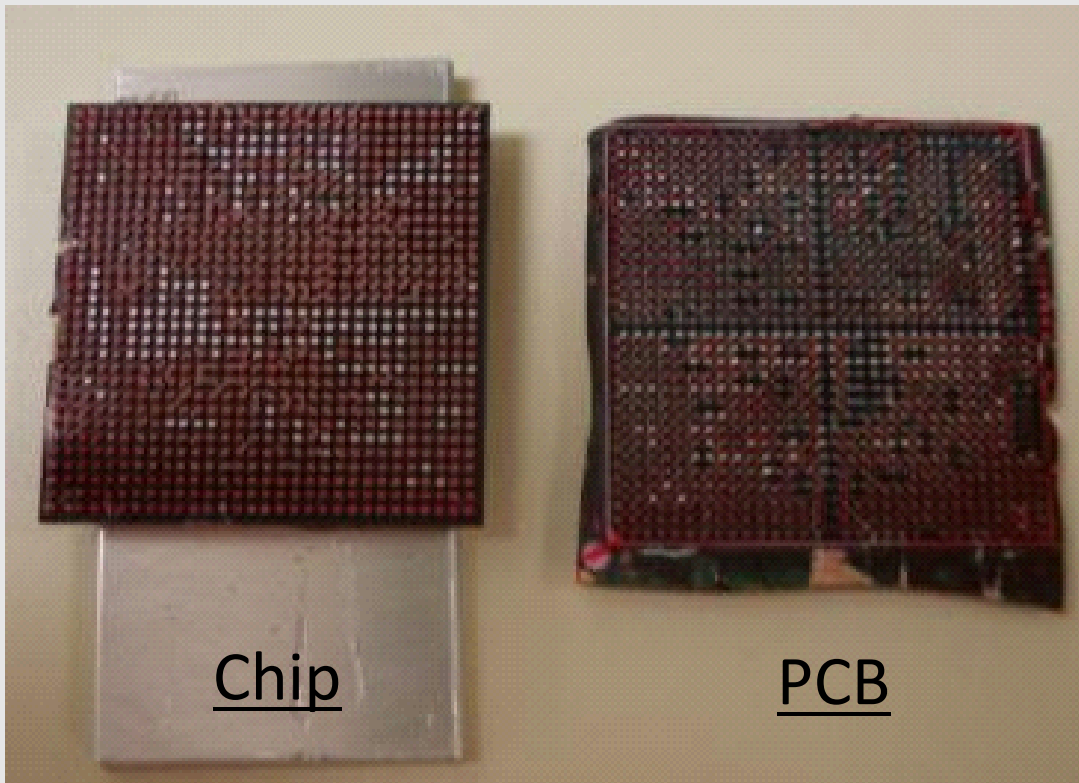
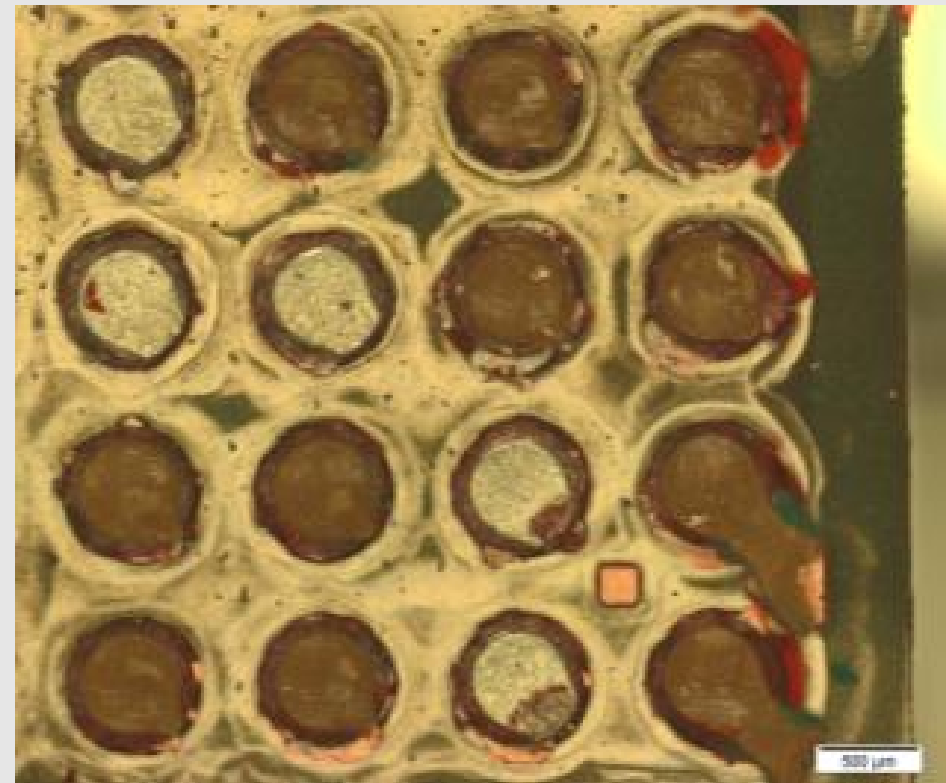
Optical Image with Extended Focal Imaging Stitching

Solder-Chip Ok	Solder-PCB Ok	Solder-PCB Ok	Solder-PCB Ok
Solder-Chip ~5%	Solder-Chip Ok	Solder-PCB Ok	Solder-PCB Ok
Solder-PCB Ok	Solder-PCB Ok	Solder-Chip ~10%	Solder-PCB Ok
Solder-PCB Ok	Solder-PCB Ok	Solder-Chip ~20%	Solder-PCB Ok

- Majority of failures (cracks from mechanical bend overstress test) observed at Solder-Chip interface
- Summary of % area cracked at each interface in the area of interest

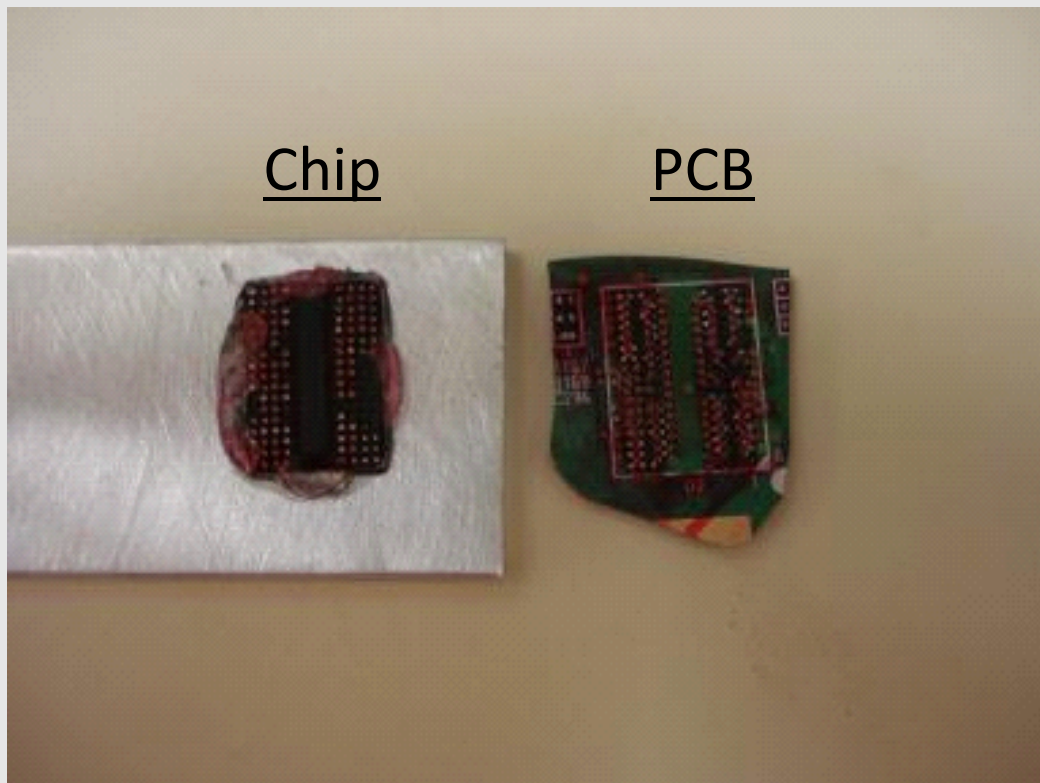
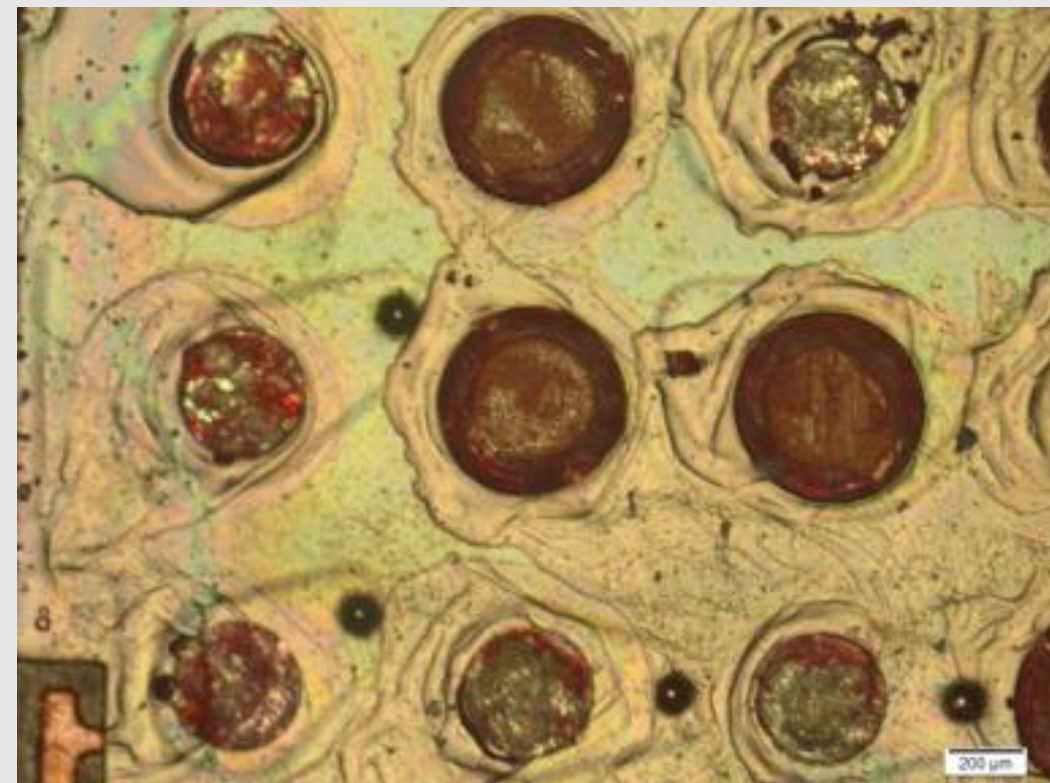
Solder-chip ~80%	Solder-PCB ~50%	Solder-chip ~5%
Solder-chip ~50%	Solder-PCB ~40%	Solder-PCB ~50%
Solder-chip ~50%	Solder-chip ~15%	Solder-Chip ~10%

- Interfacial fracture / cracks observed at two locations: Solder-CU-PCB Interface and Solder Chip interface
- Summary of % area cracked at each interface in the area of interest

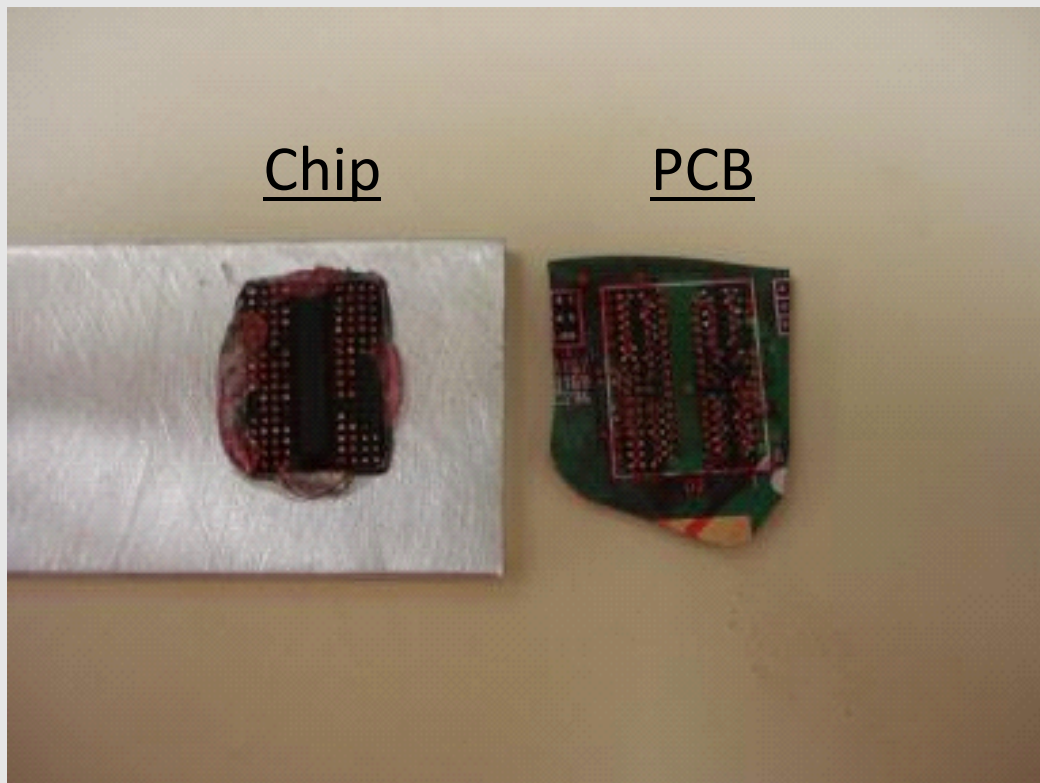
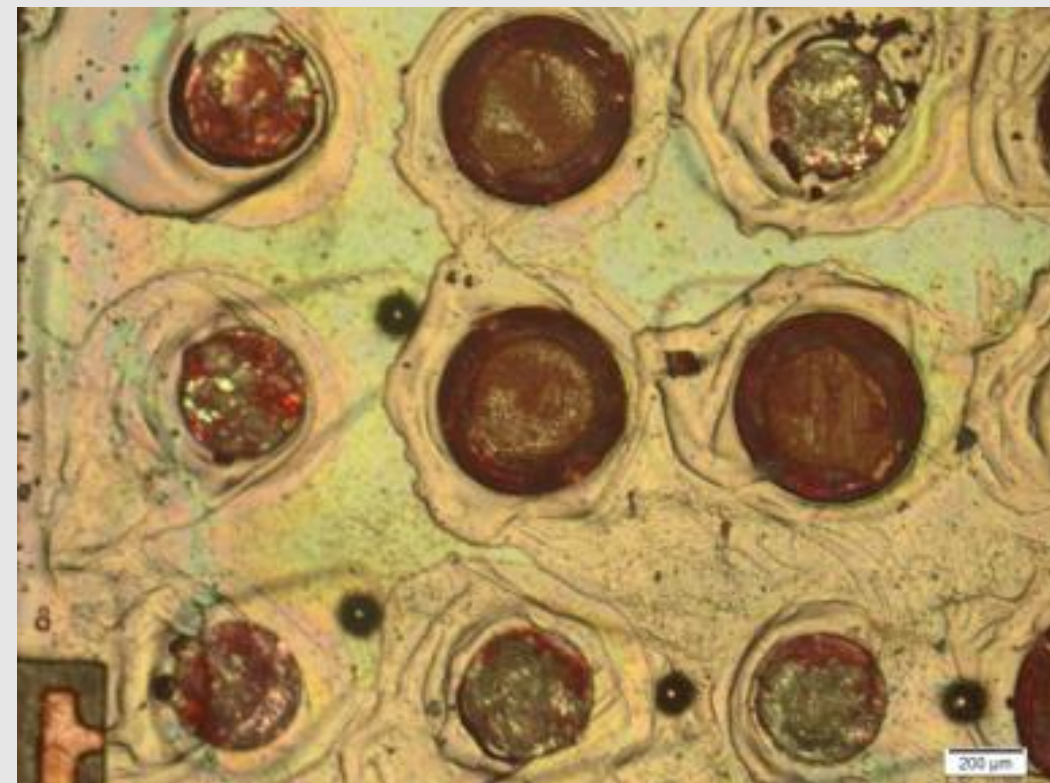
Images show the fracture surface after three point bending test.
Presence of red dye indicates cracks in the area of interest

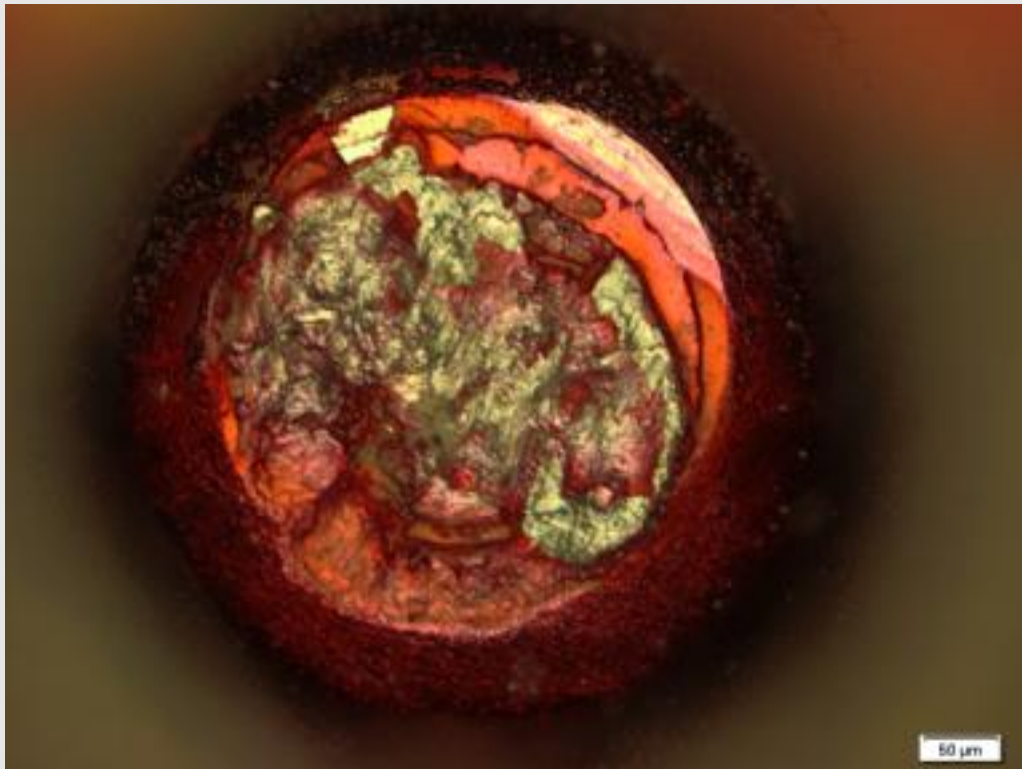
A solder joint on the PCB side

**Images show the fracture surface after three point bending test.
Presence of red dye indicates cracks in the area of interest**

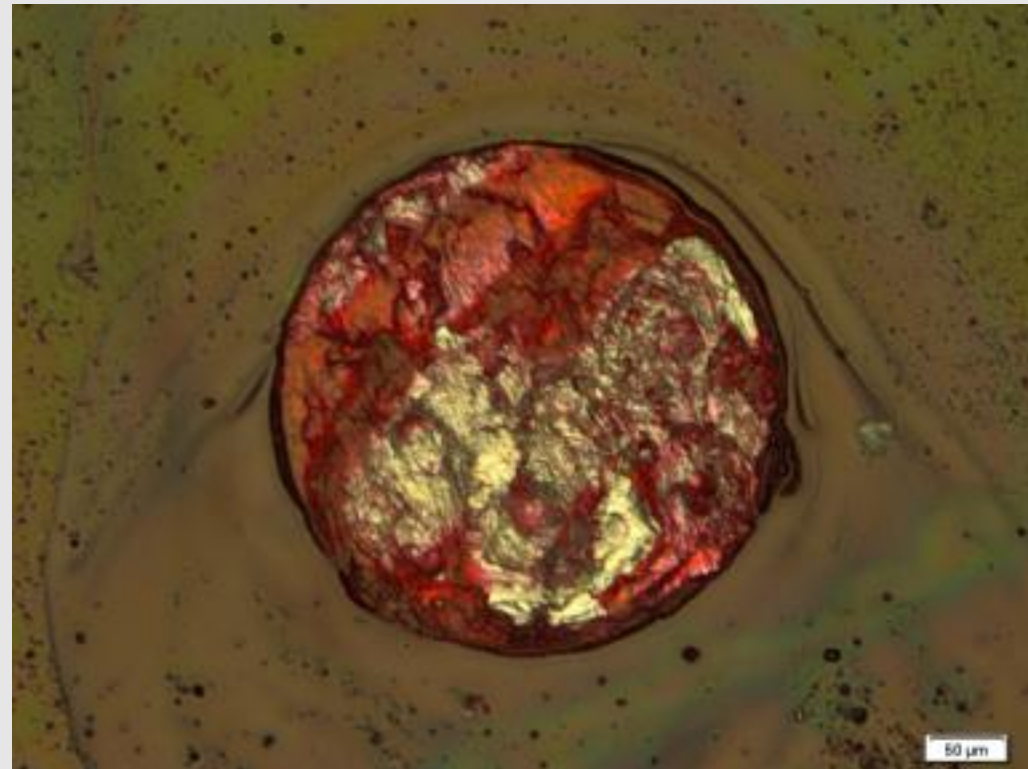
A solder joint on the chip side
