Cascade Engineering Services, Inc.

# X-Ray and Electron Probing Applications

# Capacitor Failure Investigation

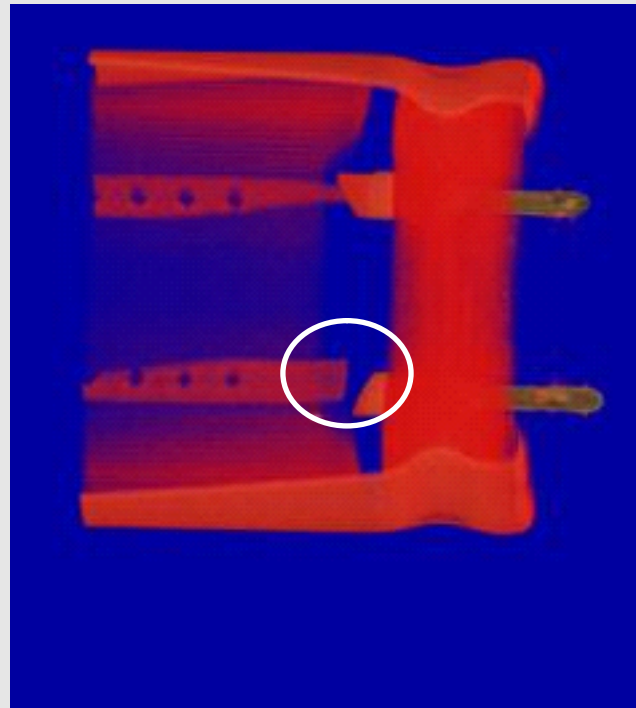
3D X-Ray: Open Terminal observed

- Separation of terminal from the electrode as the failure site confirmed
- 3D X-Ray helped identify the cross-section site for further failure investigation

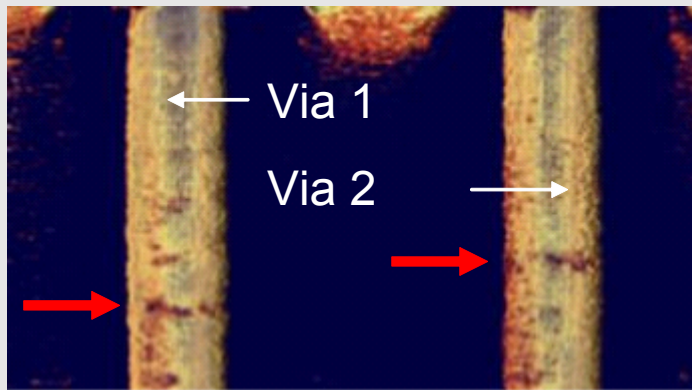
Capacitor: 3D X-Ray Image, cross section view

- Cracks observed in both vias from X-Ray imaging confirmed by SEM
- 3D X-Ray helped identify the cross-section site for further failure investigation

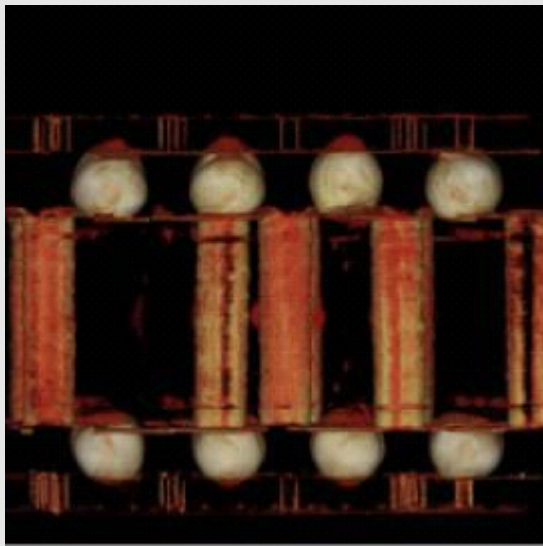
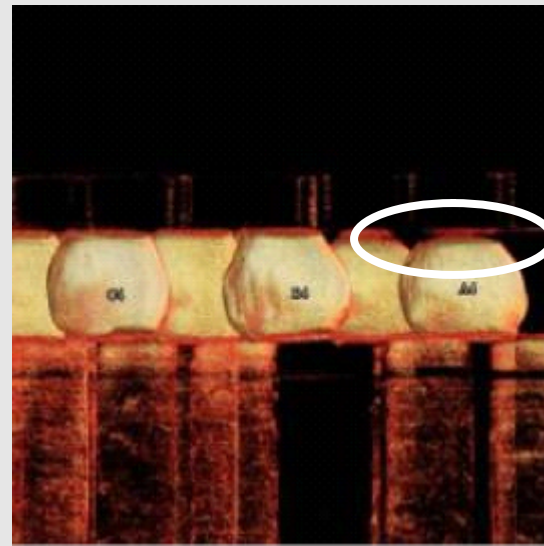
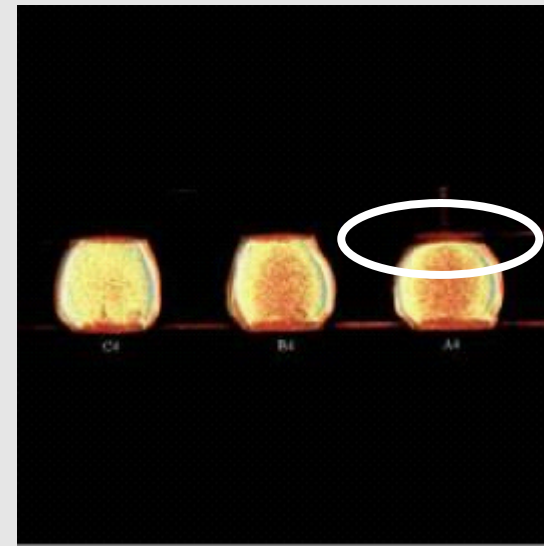
## 3D X-Ray Images

- Solder joints delamination on the chip side observed in 3D X-Ray and confirmed by SEM Imaging

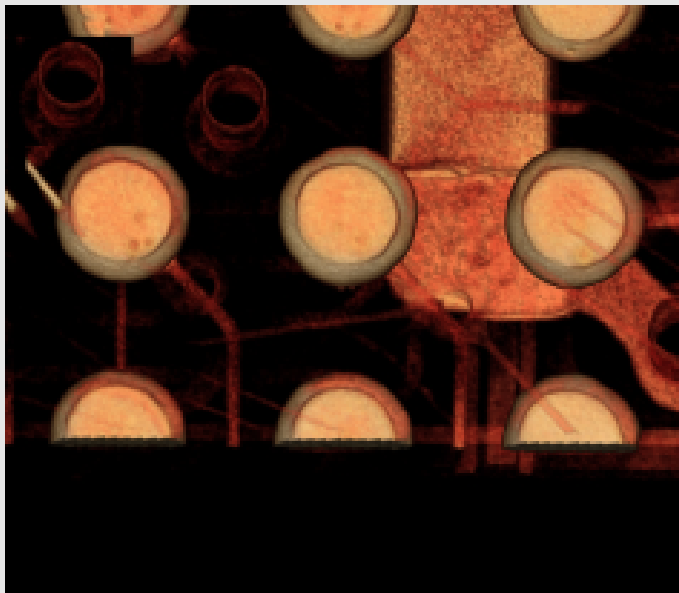
3D X-Ray Image

Crack observed in 3D X-Ray imaging and confirmed by SEM imaging

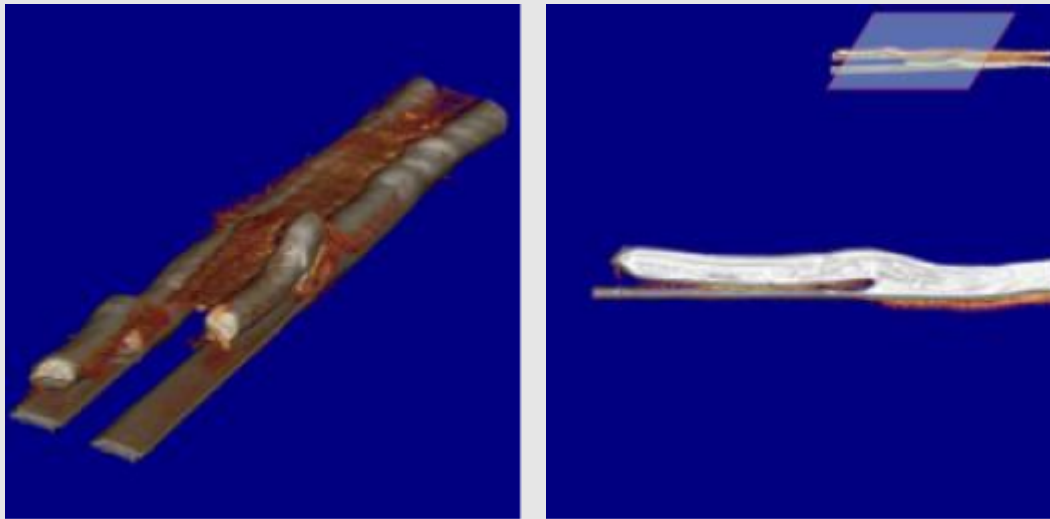
3D X-Ray Images

- Insufficient soldering observed in the 3D X-Ray imaging and confirmed by SEM imaging
- Combination of techniques: useful tool for quality / inspection applications

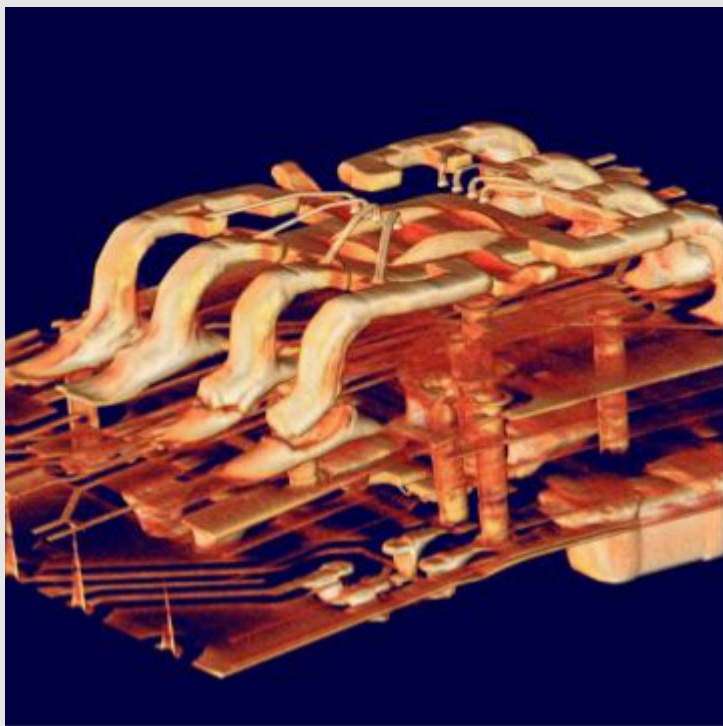
3D X-Ray Image

- Overstress failure resulting in delamination at multiple interfaces (PCBA-Bond Pad and Solder-Bond Pad)
- Obvious failures-eliminating the need for one of the tools either SEM or X-Ray depending on destructive or non-destructive technique

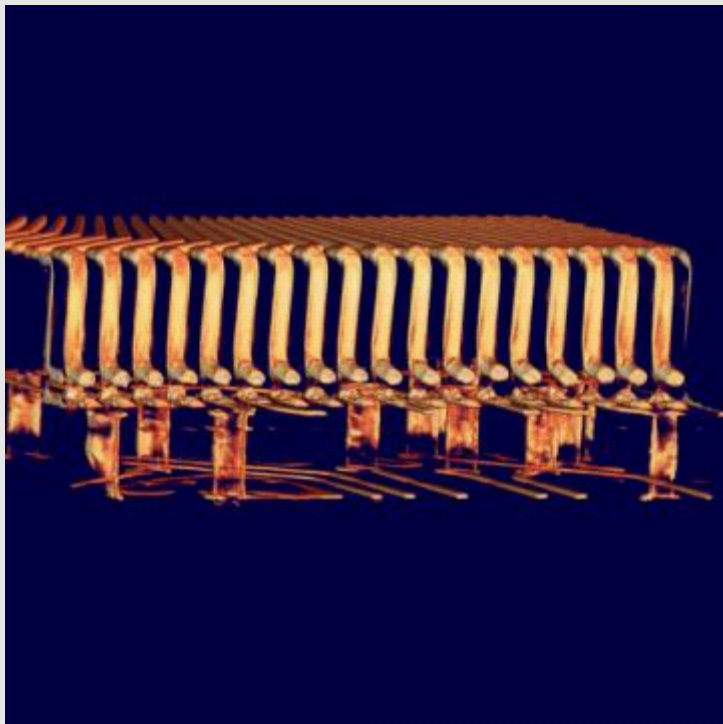
3D X-Ray Image

- Overstress failure resulting in delamination at multiple interfaces (PCBA-Bond Pad and Solder-Bond Pad)
- Obvious failures-eliminating the need for one of the tools either SEM or X-Ray depending on destructive or non-destructive technique

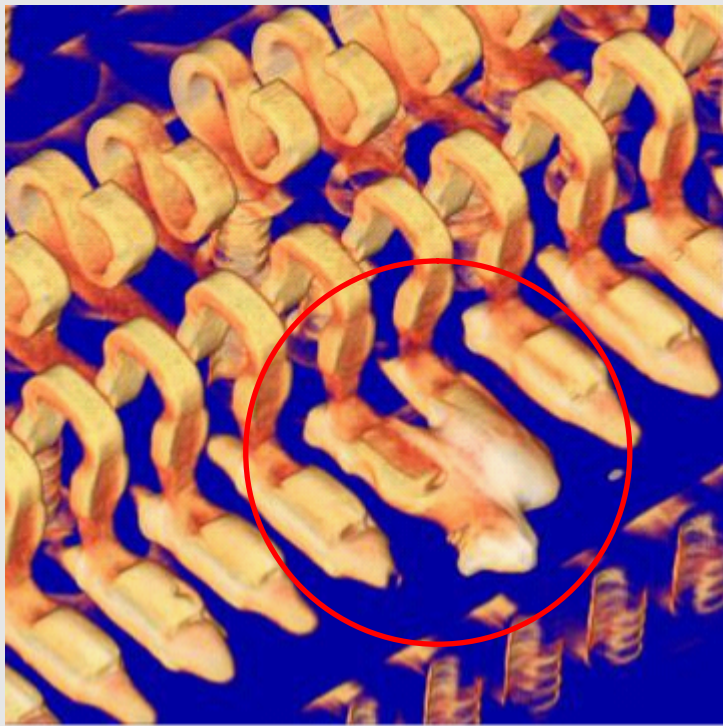
3D X-Ray Image

- Bridging of joints – highlighting the importance of 3D X-Ray as a quick and effective inspection tool

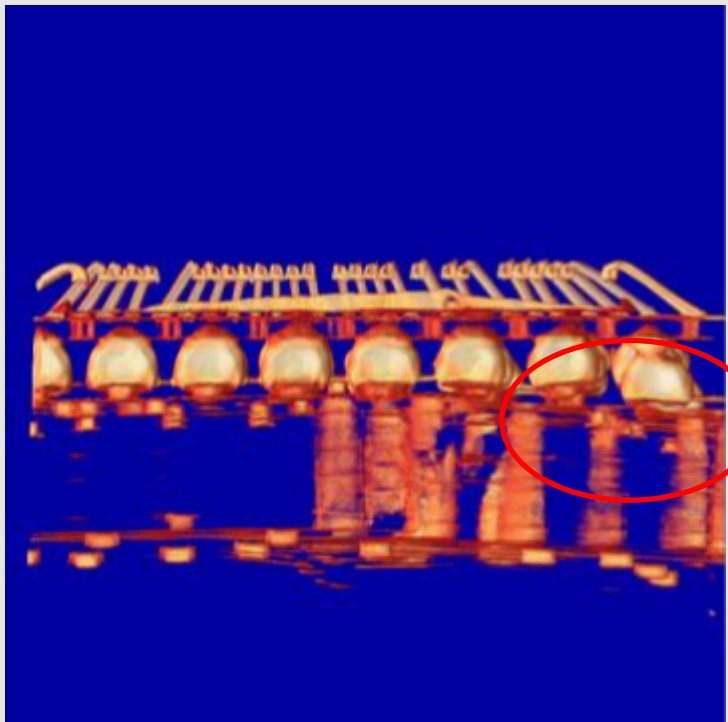
3D X-Ray Image

- Overstress failure resulting in delamination at multiple interfaces (PCBA-Bond Pad and Solder-Bond Pad)
- Failure confirmation from X-Ray eliminates the need for SEM if non-destructive technique is called for
